FY08 Forest Service Aviation Accident Review

For accident prevention purposes only

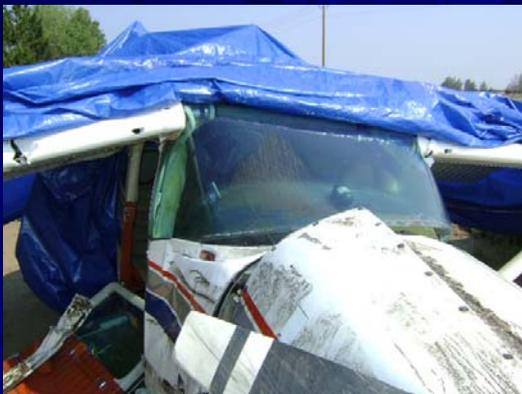
Contributing Factors

- Cracked propeller crankshaft
- Blown prop seal
- Loss of power due to intentional engine shutdown
- Distractions during approach from obstacles, residual power and oil on windscreen

- 4 point restraint systems, when properly worn, are extremely effective.
- After market technology modifications in the cockpit could contribute to injury and/or impede egress.
- Ergonomic design of seats and cockpit is an important part of mitigating risks in crash survivability.
- Increasing trends in single engine forced landings dictate a need for more training and evaluation in this area.

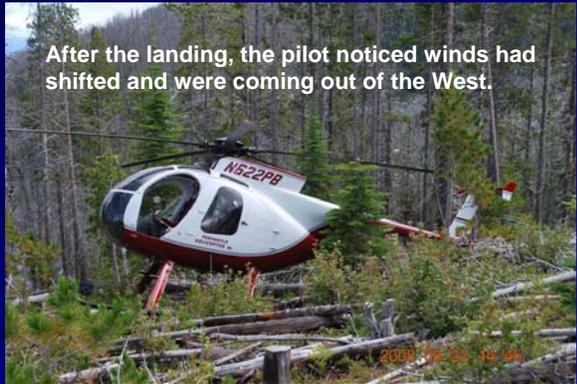
Damage

- The pilot cushioned the landing with collective "to the stops", and reduced power to flight idle as the aircraft simultaneously rocked backward making contact against timber debris with the tail rotor.

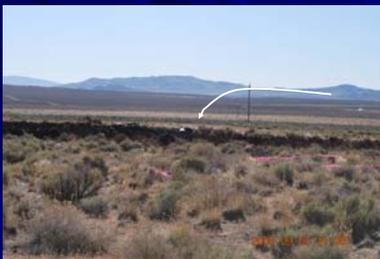
■ The initial onsite examination revealed that about 500 feet from the departure end of Runway 32, several identifiable pieces of the airplane's left jet engine were located.

It was also revealed that prior to impacting terrain the airplane had collided with a set of power-lines, estimated to be about 50 feet high. The damage assessment also revealed that the airplane had sustained significant fragmentation and thermal damage throughout the debris path.

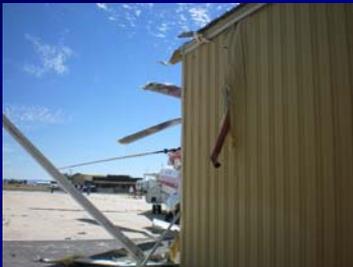
The three rear rotor blades heavily damaged the metal framed hangar structure resulting in a large debris field stretching out to 100 feet. There were no injuries! The aircraft was shut down in place and contacts were made.
