FY08 Forest Service Aviation Accident Review

For accident prevention purposes only

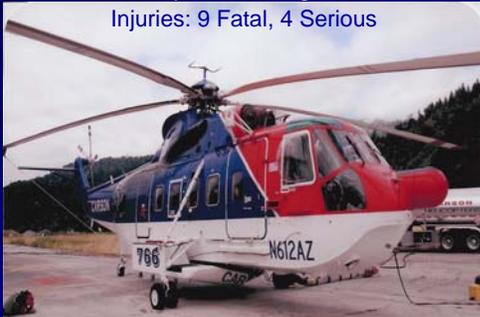
Aircraft: Sikorsky S-61N, Registration: N612A

- N612AZ was transporting 10 contract firefighters from Helispot 44 (H-44, elevation 5,935 feet) en route to Helispot 36 (H-36, elevation 2,516 feet) when the accident occurred.

■ The helicopter impacted trees and terrain near Weaverville, California in the Trinity Alps Wilderness while supporting the Buckhorn fire.

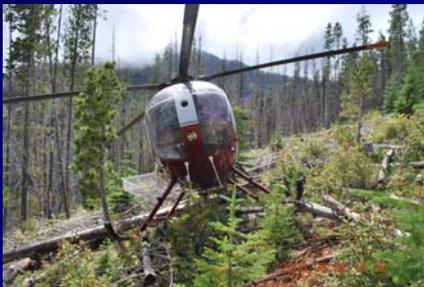
NTSB Identification: **SEA08TA188**
Monday, August 18, 2008, near Bonners Ferry, ID
Aircraft: Hughes 369D, registration: N622PB
Injuries: 4 Uninjured.

- Aircraft was moving 3 firefighters from the Fisher Peak helispot to the Bonners Ferry Ranger station after initial attack on Parker canyon fire.
- Pilot was on 17th day of work with one day off during that period.

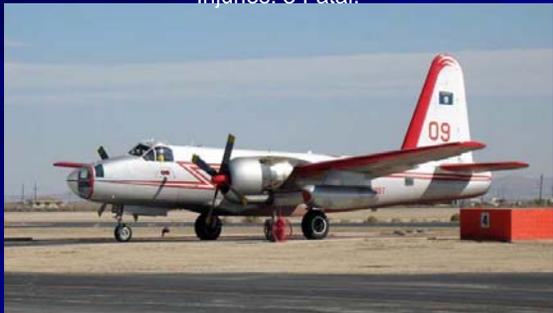
NTSB Identification: **SEA08GA194**
Accident occurred September 01, 2008 in Reno, NV
Aircraft: Lockheed SP-2H, registration: N4235T
Injuries: 3 Fatal.

to 300 feet above the ground, he observed the left jet engine emitting flames, followed by the left wing being engulfed in flames.

It was also revealed that prior to impacting terrain the airplane had collided with a set of power-lines, estimated to be about 50 feet high. The damage assessment also revealed that the airplane had sustained significant fragmentation and thermal damage throughout the debris path.

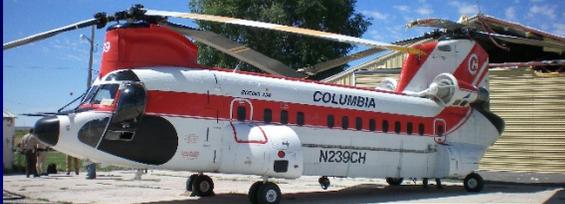
On Friday, August 22nd at 11:18am, a Boeing 234, N239CH, was maneuvering into the fueling area at the Burns airport when the rear main rotor blades struck the upper portion of a nearby hangar. The aircraft was ferrying to do a bridge project on a forest in Utah.

The three rear rotor blades heavily damaged the metal framed hangar structure resulting in a large debris field stretching out to 100 feet. There were no injuries! The aircraft was shut down in place and contacts were made.

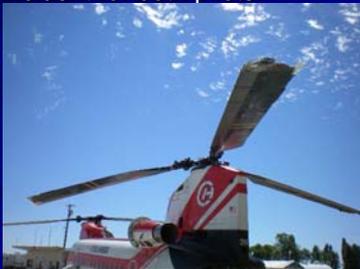
Due to the rotational direction of the rotor, most of the debris was flung toward the runway with only minor deposits in the area of the witnesses.
